PROPERTY INSPECTION REPORT

1234 Main Street
Anywhere, USA

DATE OF INSPECTION: May 10, 2007
TIME OF INSPECTION: 2:00 PM
CLIENT: XX XXX XXXXX
REALTOR/BUYER'S AGENT: Mr. Bill Doran and Mr. Steve Devey
Weichman Associates Realtors
INSPECTION LOCATION: 1234 Main Street, Anywhere, USA
INSPECTED BY: Jeff Kirkpatrick

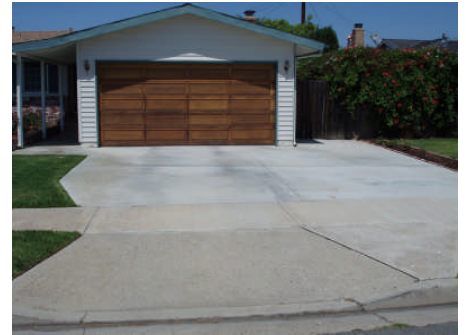
1. DRIVEWAY
TYPE & CONDITION:

Concrete. The concrete driveway appears to be in serviceable condition.

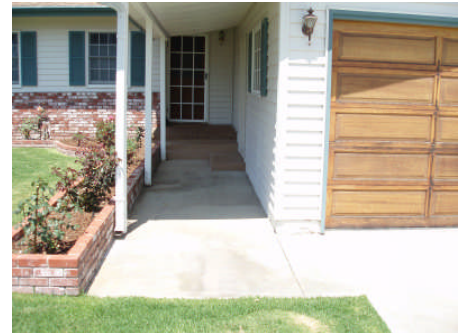
2. SIDEWALKS
TYPE & CONDITION:

Concrete. The sidewalks appear to be in serviceable condition.

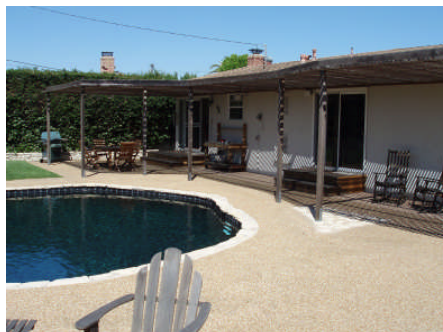
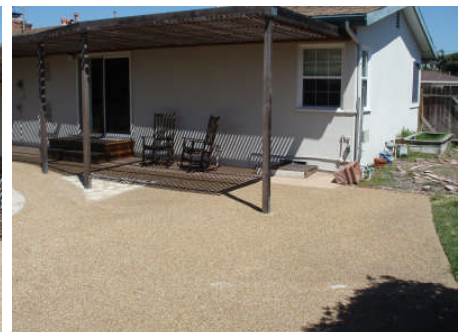
4. PATIO
TYPE & CONDITION:

Concrete with a pebble/epoxy coating. There are cracks visible through the epoxy coating on the backyard patio. The epoxy/pebble coating has many loose pebbles. I recommend evaluation by a licensed concrete contractor.

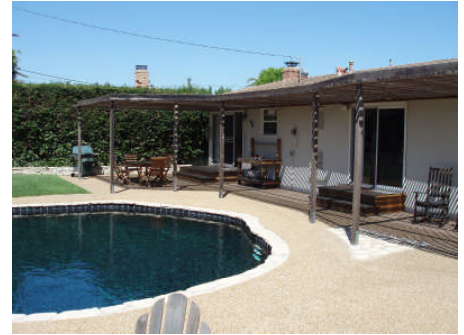
**5. DECK/PATIO/PORCH COVER
TYPE & CONDITION:**

Wood. The patio cover appears to be in serviceable condition.

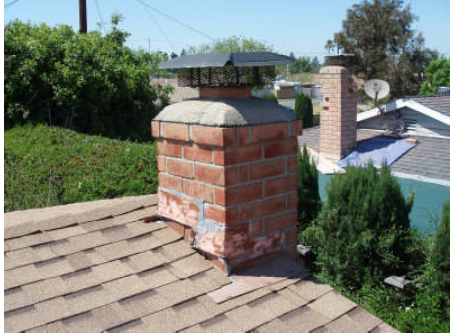
11. **CHIMNEY**
LOCATION: Family room
TYPE & CONDITION: Masonry. The chimney appears to be in serviceable condition. There is a combination spark screen/rain cap present.

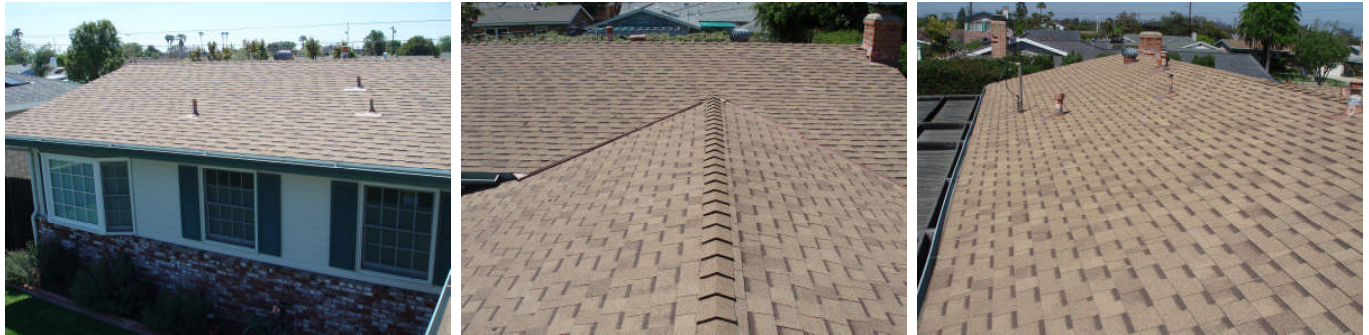
19. ROOFING MATERIALS: Asphalt composition shingles **LOCATION:** All

CONDITION: The roofing appears to be in serviceable condition and within its useful lifespan.

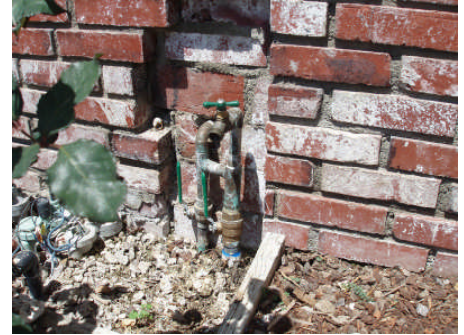
The main water line and shut off valve appear to be in serviceable condition.

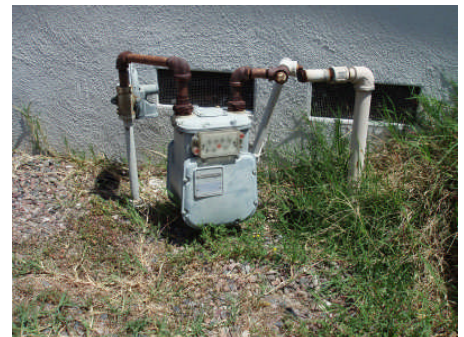
The natural gas valve and meter are located on the exterior west side of the house. The natural gas meter and valve appear to be in serviceable condition.

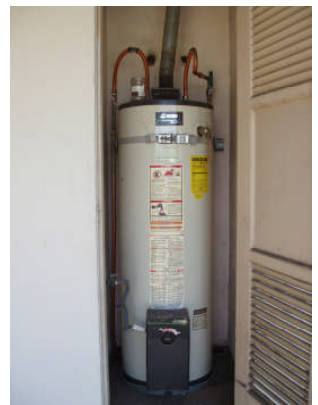
27. WATER HEATER

TYPE, SIZE & LOCATION: Tank type, 50 gallon, natural gas, located in an exterior closet at the rear patio. Reliance, Serial # J96655336

- a. The vent piping appears to be in serviceable condition.
- b. Combustion air is available.
- c. There is a water shutoff valve installed. The valve appears to be in serviceable condition.
- d. The burner flame appears typical.
- e. The water heater is not properly strapped to resist movement during seismic activity. I recommend evaluation by a licensed contractor.

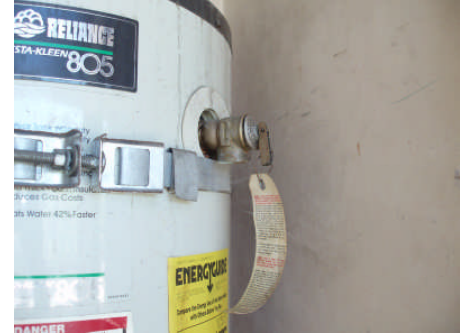
27. WATER HEATER (Continued)

- f. The TPR valve does not have drain piping attached. Drain piping that terminates near the ground at the exterior of the building is required. I recommend evaluation by a licensed plumbing contractor.

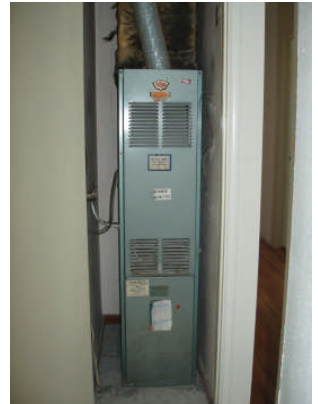
28. FURNACE DESCRIPTION:

MANUFACTURER AND MODEL NUMBER:	Utility Appliance Corp., Model #75FAF Serial # PA 05204
APPROXIMATE BTU's:	75,000
LOCATION:	Hallway closet
HEATING TYPE:	Vertical forced air
FUEL TYPE:	Natural Gas

29. **FURNACE CONDITION:** The furnace does not appear to have been recently serviced per the manufacturer's instructions. I recommend evaluation and service by the natural gas service provider prior to the close of escrow.

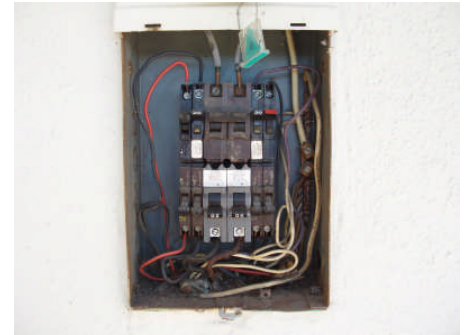
51. MAIN ELECTRICAL PANEL:
MAIN PANEL LOCATION: Exterior, located on the north side of the house

MAIN PANEL: 100-amp service. There is a ground present.

54. ELECTRICAL PANEL NOTES: The main electrical panel is an older style Federal Pacific 'Stab-lok' panel. This type of electrical panel does not have a main disconnect switch. I recommend upgrading to a newer style electrical panel. I recommend evaluation by a licensed electrical contractor.

- 54. ELECTRICAL PANEL NOTES:** The main electrical panel is an older style Federal Pacific 'Stab-lok' panel. This type of electrical panel does not have a main disconnect switch. I recommend upgrading to a newer style electrical panel. I recommend evaluation by a licensed electrical contractor.

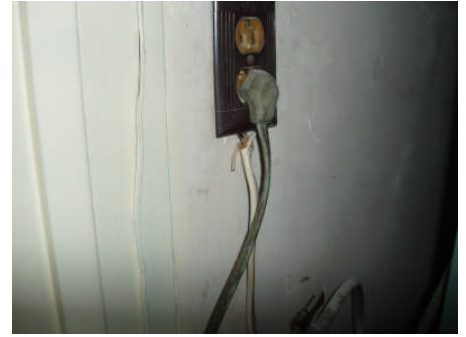
55. WIRING NOTES: (Continued)

- f. There is improper electrical wiring in the furnace closet. There is exposed non-metallic sheathed cable that is improperly connected to the receptacle. I recommend evaluation by a licensed electrical contractor.

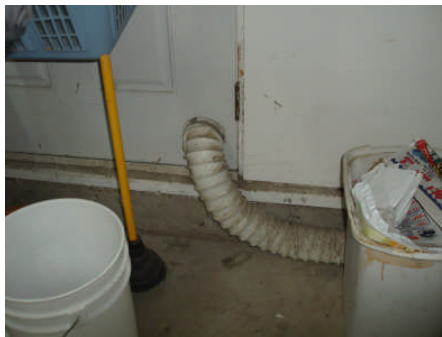
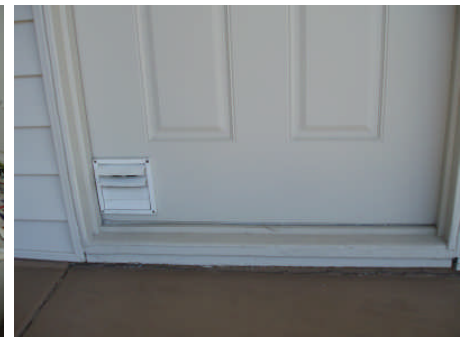
66. LAUNDRY
LOCATION: Garage

- COMMENTS:**
- a. The hot and cold-water valves appear serviceable.
 - b. The 120-volt outlet appears serviceable and properly grounded.
 - c. The 208/230-volt power is not provided.
 - d. The natural gas service appears operable. There is a shut off valve installed.
 - e. The dryer vent piping is not properly installed. Current flexible dryer vent ducting is installed the garage floor. The dryer vent ducting terminates in the exterior garage door. The dryer vent ducting should be hard piped and should not terminate in the door. I recommend evaluation and repair.

- 66. LAUNDRY COMMENTS:**
- e. The dryer vent piping is not properly installed. Current flexible dryer vent ducting is installed the garage floor. The dryer vent ducting terminates in the exterior garage door. The dryer vent ducting should be hard piped and should not terminate in the door. I recommend evaluation and repair.

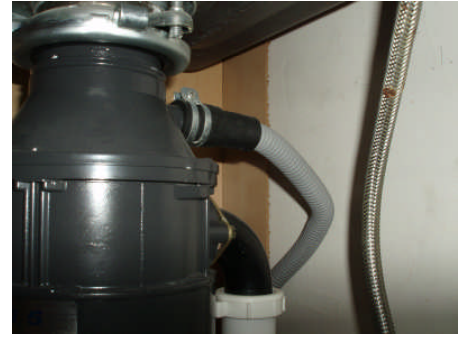
**68. KITCHEN SINK:
CONDITION:**

- a. The dishwasher drains in to the garbage disposal without going through an air gap device. An air gap device prevents waste products from backing up into the dishwasher. I recommend evaluation by a licensed plumbing contractor.

- 68. KITCHEN SINK:
SINK PLUMBING:**
- a. The dishwasher drains in to the garbage disposal without going through an air gap device. An air gap device prevents waste products from backing up into the dishwasher. I recommend evaluation by a licensed plumbing contractor.

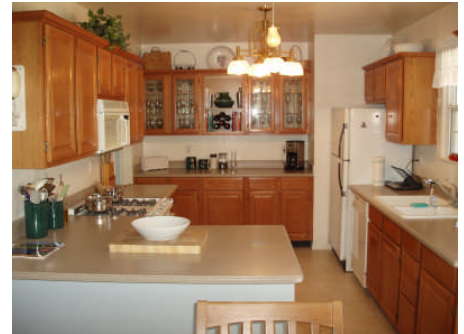
69. KITCHEN GENERAL:

- a. The kitchen cabinets appear to be in serviceable condition.
- b. The kitchen flooring appears to be in serviceable condition.
- c. The kitchen counter tops appear to be in serviceable condition.

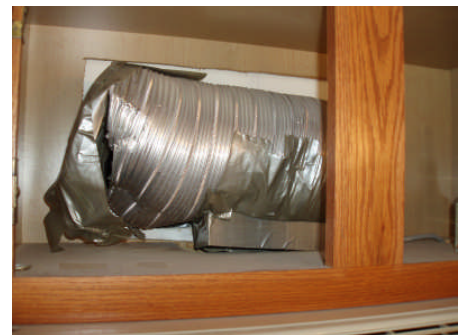
71. RANGE/COOKTOP:

- a. The natural gas range and oven appear to be in serviceable condition. The oven door gaskets appear serviceable.
- b. The exhaust fan ducting is not properly connected in the cabinet over the microwave oven. I recommend evaluation by a licensed contractor.

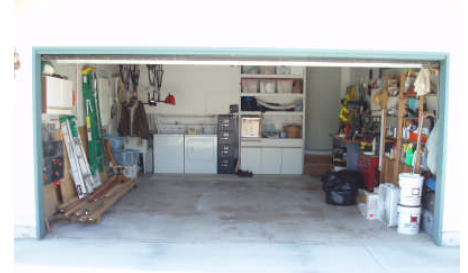
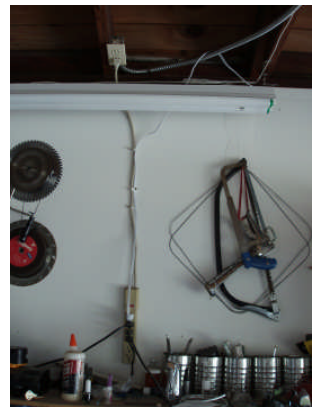
77. **MAIN HOUSE GARAGE:** Attached, two-car.
78. **GARAGE FLOOR:** Concrete. The garage floor appears to be in serviceable condition. There is a large crack in the middle of the garage floor. The crack is likely the result of expansion in the highly expansive soil in this area.

81. **DOOR TO LIVING SPACE:** The door leading from the garage to the living space is not self-closing and latching. This door is part of a fire rated assembly and should be self-closing and latching. I recommend evaluation by a licensed contractor.

84. **AUTOMATIC OPENER:** The automatic reverse safety sensors are installed approximately 24" above the floor. These sensors are required to be installed between four and six inches above the garage floor. I recommend evaluation and repair.

85. **GARAGE ELECTRICAL:** There are extension cords being used as permanent electrical wiring in the garage. Extension cords are not designed or constructed for use as permanent electrical wiring. I recommend evaluation by a licensed electrical contractor.

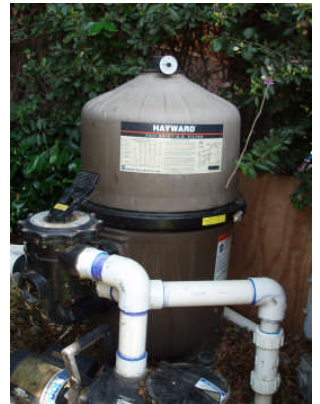
89. **POOL FILTER:** There is a diatomaceous earth filter installed. There is a pressure gauge and bleeder valve installed. The filter, pressure gauge, and bleeder valve appear to be in serviceable condition.

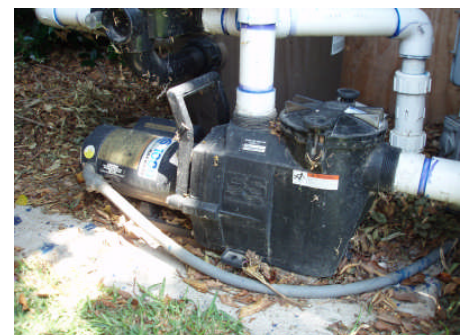
90. **POOL PUMPS:** There is one pump installed. The pump appears to be in serviceable condition.

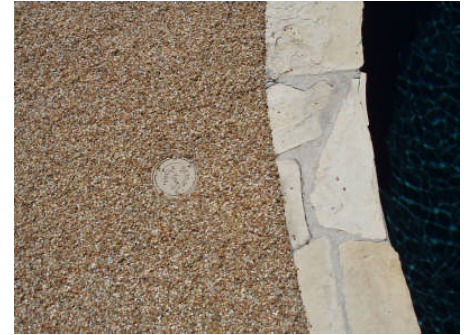
92. POOL ELECTRICAL:

a. The pool light is connected to a 'GFCI' receptacle attached to the exterior rear wall of the house. The operation of the light is controlled by the test and reset buttons on the 'GFCI' device. The pool light should be connected to a switch. Continuous use of the test and reset buttons will lead to premature failure of the 'GFCI' device. I recommend evaluation by a licensed electrical contractor.

b. The pool light junction box is mounted in the pool deck at the south end of the pool. This is an older style junction box. Current electrical standards require the junction box to be mounted above the pool deck. I recommend evaluation by a licensed electrical contractor.

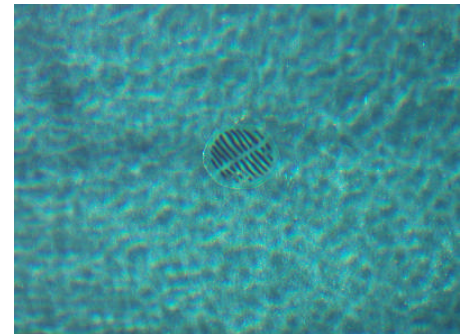
93. POOL GENERAL:

d. The pool drain cover is an older style drain cover. This type of drain cover has been known to present a safety hazard as objects can be trapped against the drain. I recommend installing a newer style anti-vortex drain cover. I recommend evaluation by a licensed pool contractor.
