PROPERTY INSPECTION REPORT

1234 Main Street
Anywhere, USA

DATE OF INSPECTION: May 9, 2007
TIME OF INSPECTION: 10:00 AM
CLIENT: xx xxx xxxxx
BUYER'S AGENT: Mr. Rick Glass
Keller Williams Realty
INSPECTION LOCATION: 1234 Main Street, Anywhere, USA
INSPECTED BY: Jeff Kirkpatrick

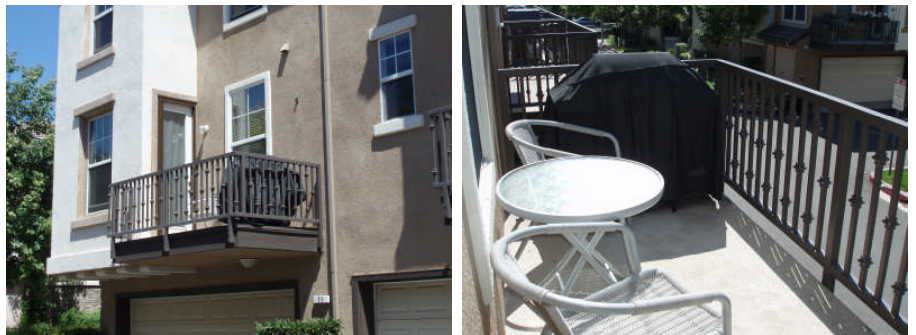
6. DECKS/PORCH

Wood framed with waterproof coating. The deck at the kitchen level appears to be in serviceable condition.

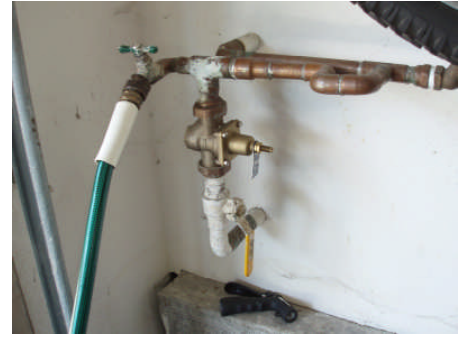
23. MAIN WATER LINE

- MATERIAL:** 1" Copper
- LOCATION:** The main water shut off valve is located on the interior southwest corner of the garage.
- CONDITION:** The main water supply piping and shut off valve appear to be in serviceable condition.

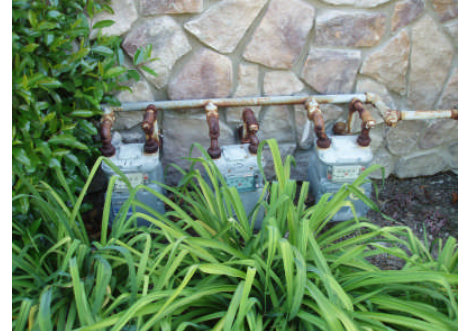
26. FUEL SYSTEM

- TYPE:** Natural gas
- METER LOCATION AND CONDITION:** West end of building. The gas meter appears to be in serviceable condition. (Left)

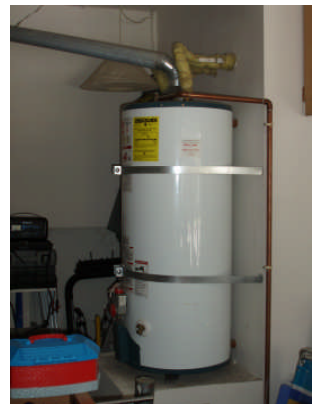
27. WATER HEATER

TYPE, SIZE, & LOCATION: Tank type, Natural gas, 40 Gallon, located in the garage, Rheem, Serial # RHLN 0101184249

- GENERAL COMMENT:**
- The vent piping appears to be in serviceable condition.
 - Combustion air is available.
 - There is a TPR valve installed with the proper drain piping.
 - There is a water shutoff valve installed. The valve appears to be in serviceable condition.
 - The burner flame is typical.
 - The water heater is properly strapped to resist movement during seismic activity.

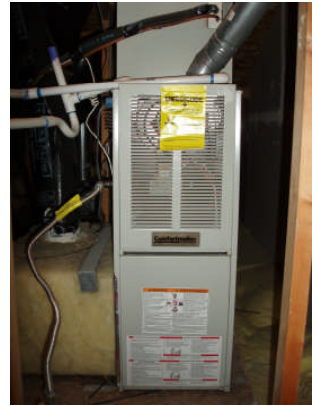
28. FURNACE DESCRIPTION

MANUFACTURER AND MODEL NUMBER:	International Comfort Products Model # NBF050B12A2 Serial # L003077878
APPROXIMATE BTU's:	50,000
LOCATION:	Attic
HEATING TYPE:	Vertical forced air
FUEL TYPE:	Natural gas

| 29. FURNACE CONDITION: | The furnace system appears to be in serviceable condition. |

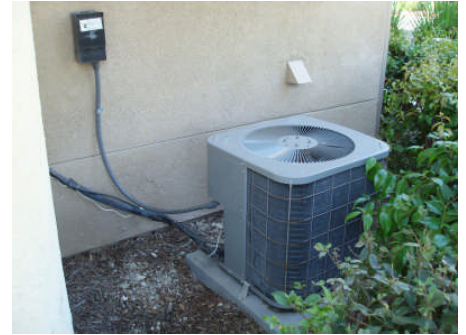
- 38. AIR CONDITIONING:** International Comfort Products, Model # WAC030AKA1, Ser. # L003636591
- a. LOCATION:** Rear patio
- b. TYPE OF SYSTEM:** Split system
- c. ELECTRICAL:** 208/230-volt. There is an electrical disconnect present.
- d. CONDITION:** The air conditioning condenser appears to be in serviceable condition. There is insulation on the refrigerant lines.

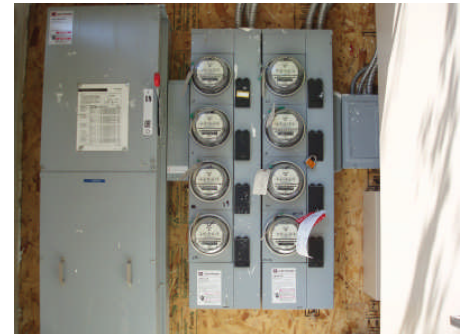
40. MAIN ELECTRICAL PANEL: MAIN PANEL LOCATION: Located in an exterior closet at the east end of the building. (Left side, second from top)

MAIN PANEL: 100 amp, there is a ground present.

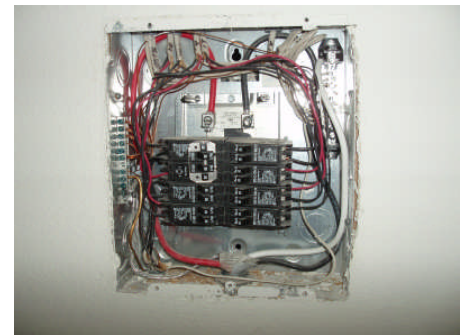
42. SUB-PANELS: Located at the top of the stairway leading from the main entry to the garage.

43. ELECTRICAL PANEL NOTES: The main electrical panel and sub-panel appear to be in serviceable condition.

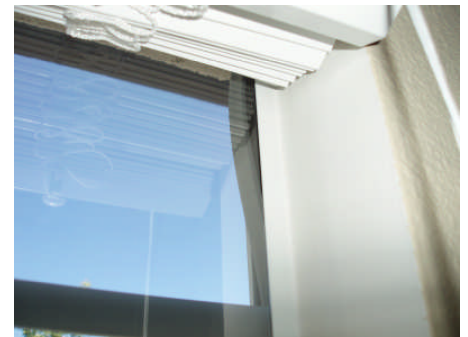
48. WINDOWS

- a. The seal is damaged between the glass panes at the middle window on the west wall of the upper level southwest bedroom. I recommend evaluation by a licensed window contractor.

35. **AIR FILTERS:** There are air filters in the upper level hallway and main level hallway. Both air filters are very dirty. I recommend changing or cleaning the air filters.
44. **WIRING NOTES:**
- e. The recessed ceiling light fixture did not respond to the switch in the main level half bath. I recommend evaluation and repair.
48. **WINDOWS
CONDITION:**
- a. The seal is damaged between the glass panes at the middle window on the west wall of the upper level southwest bedroom. I recommend evaluation by a licensed window contractor.

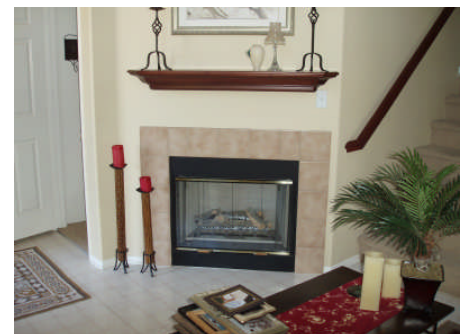
52. FIREPLACE:

Pre-fabricated unit. The family room fireplace appears to be in serviceable condition. This is a natural gas burning appliance only. No other type of combustible material should be burned in this fireplace.

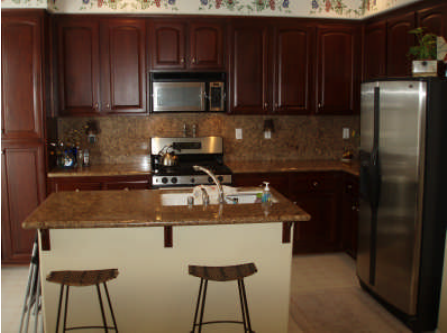
- b. The plumbing in the cabinet under the sink appears to be in serviceable condition.
- 58. KITCHEN GENERAL:**
- a. The kitchen cabinets appear to be in serviceable condition.

- b. The kitchen flooring appears to be in serviceable condition.
 - c. The kitchen counter tops appear to be in serviceable condition.
-

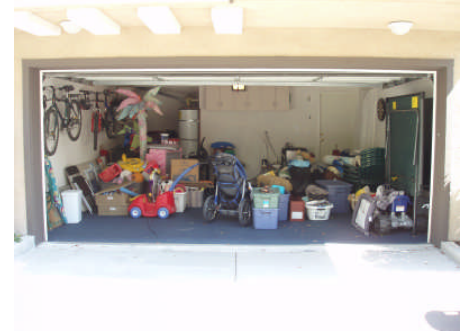
78. **GARAGE FLOOR:** Concrete. The garage floor appears to be in serviceable condition. The garage floor was covered with carpeting and was not fully visible.
